## RAILWAY ACCIDENTS

# REPORT ON THE COLLISION

which occurred on the 2nd January, 1947, at GIDEA PARK

on the London and North Eastern Railway

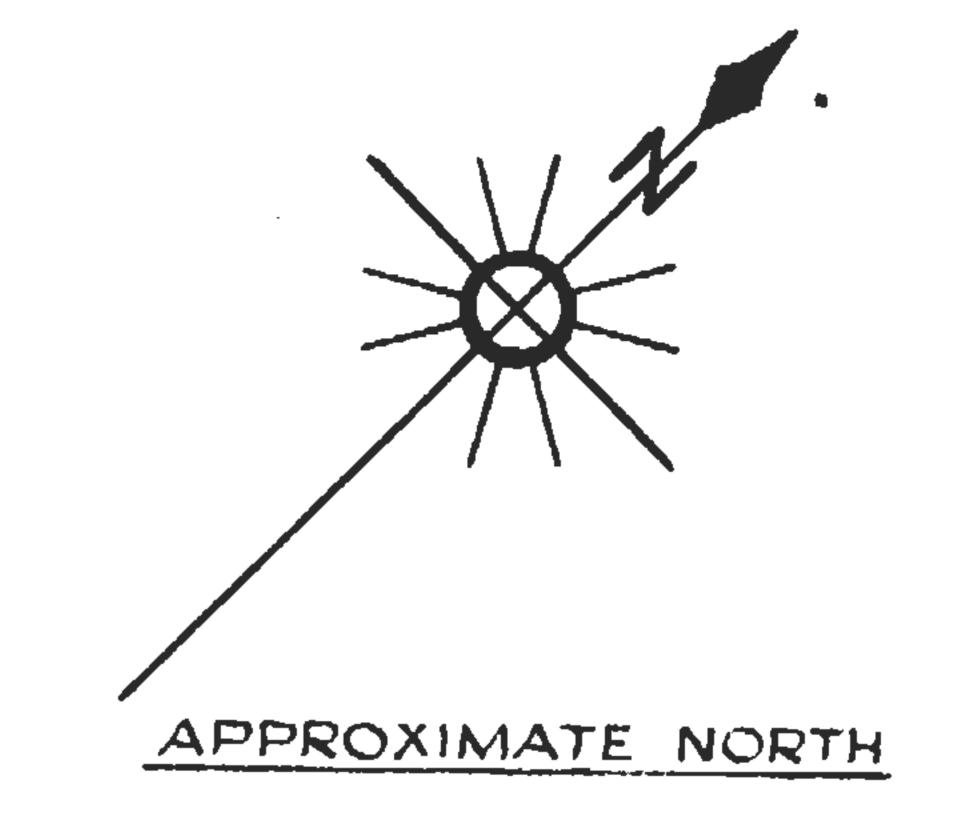
# L. N. E. R. (SOUTHERN AREA) COLLISION AT GIDEA PARK 2ND JAN. 1947

CROWLANDS S.B. 11/4 MILES
ROMFORD S.B. 12/4 MILES
GIDEA PARK STATION 13/4 MILES
GIDEA PARK S.B. 133/4 MILES

Position of Fog Posts shown thus ..... F.P.

TRACK CIRCUITS SHOWN THUS .....

The signalling arrangements on the Down Through line, with relevant distances, are shown on the accompanying diagram. Sykes lock and block is in use from Liverpool Street to Romford inclusive, with the usual controls to ensure that the signals are worked in proper sequence, and to prevent a second train being accepted unless they have been restored to Danger (or Caution) bebind the one preceding it. There is no manual block working between Romford and Gidea Park, as the line is continuously track circuited. The signals from Romford advanced starter onwards are controlled by track circuit, with apparatus to ensure that they are put to Danger behind each train. Train descriptions are passed forward from Romford on magazine train describers, having storage for three successive descriptions. If the Romford signalman omits to set up a description on the apparatus when a train passes his box an N.D. (i.e. not described) indication appears on the Gidea Park instrument as soon as the train passes Romford advanced starting signal (No. 18) and occupies track circuit N; the Gidea Park signalman's attention is drawn to the appearance of any fresh description on his instrument by the sounding of a buzzer. There is also a block bell circuit between the boxes for use if the describing apparatus fails, and for emergency bell signals.
